# 1999-2000 Protégé 1.8L Ignition Coil [Emission Recall 0702F]

SUBJECT: Recall Campaign 0702F

1999 – 2000 Protégé 1.8L – Ignition Coil

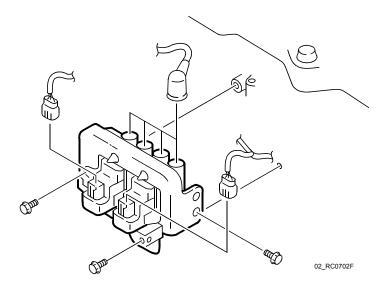
On some 1999 and 2000 Protegé vehicles equipped with the 1.8L engine, the driving performance may deteriorate, causing hesitation, rough idle, and/or Malfunction Indicator Lamp (MIL) illumination, due to failure of the ignition coil.

- 1. Remove the ignition coil:
  - a. Remove the 2- electrical connectors.
  - b. Remove the 4- coil plug wires.
  - c. Remove the 3- mounting bolts.

- 2. Install the new ignition coil:
  - a. Install the 3-mounting bolts.
  - b. Torque the mounting bolts to 19-25Nm (14-18 ft-lb).
  - c. Connect the 2- electrical connectors.
  - d. Connect the 4- coil plug wires.
