**Automatic Shoulder Belt  
Recall Campaign [72803]  
Door Latch Switch [SSP31]**

**1990-1994 323  
1992-1993 MX-3  
1990-1993 Protege**

**SUBJECT:** **Recall Campaign 72803 & Special Service Program – SSP31**  
1990 – 1994 323, 1992 – 1993 MX-3 and 1990 – 1993 Protege

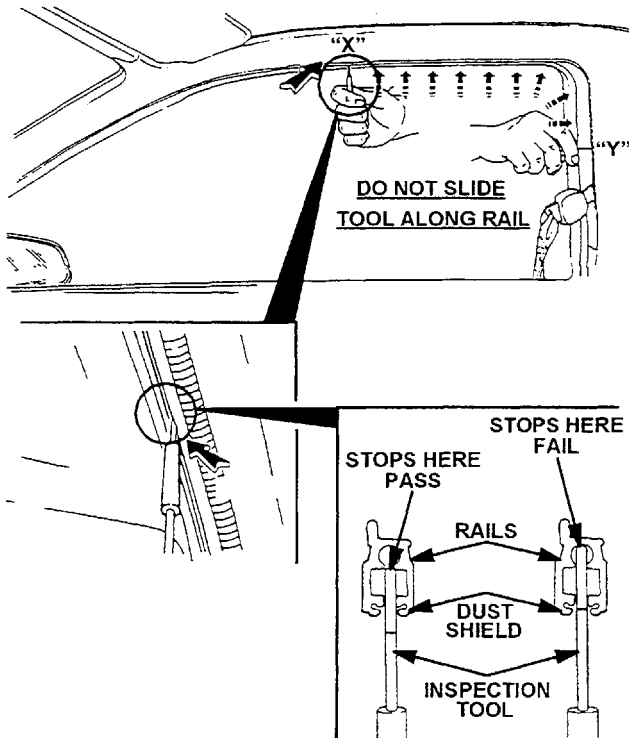
4. If the inspection tool's depth does not increase (tool's scribe line does not move closer to the dust shield), proceed to "C. BUCKLE OPERATION INSPECTION" for the other front door. Proceed to "H. AUTOMATIC SHOULDER BELT OPERATION INSPECTION" if the necessary inspection and repair has been completed on both sides.
- If the inspection tool's depth increases anywhere between "X" and "Y", Proceed to "G. RAIL ASSEMBLY REPLACEMENT".

1. Check and record the vehicle mileage.
  2. Close the front door.
  3. Turn ON the ignition to move the automatic shoulder belt to the center pillar.
- Insert the inspection tool P/N 9999-95-R728-03 (OTC P/N T97C-61610B45-A) between the dust shields of the rail assembly at position "X" as shown below.

IF MILEAGE IS LESS THAN 80,000 (128,000KM), USE THE 3.2MM END OF THE INSPECTION TOOL.

IF MILEAGE IS MORE THAN 80,000 (128,000KM). USE THE 3.4MM END OF THE INSPECTION TOOL.

- Tool must be inserted until it stops in the rail assembly.
- Record the distance between the scribe line on the tool and dust shields.
- Insert and inspect every 1/2 inch from point "X" to point "Y" along the rail assembly.
