Malfunction Indicator Light Illumination – DTC P2006 Recall Campaign [4807H]

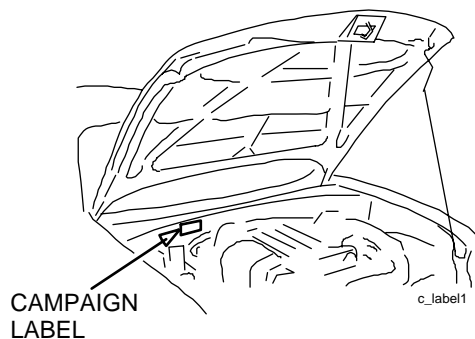
1. Perform a Warranty Vehicle Inquiry using your eMDCS System and inspect vehicle for a Campaign Label **RECALL 4807H** attached to the vehicle's bulkhead. Refer to eMDCS System - Warranty Vehicle Inquiry Results table below.

NOTE: Verify Recall number as the vehicle may have multiple recalls.

1. Fill out a blue "Campaign Label" (9999-95-065A-05) with Campaign No: "4807H", your dealer code, today's date, and affix it to the vehicle's bulkhead as shown in "A. VEHICLE INSPECTION PROCEDURE".

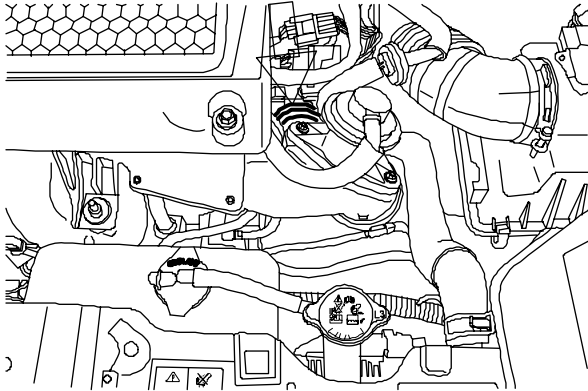
1757a

1. Remove engine cover.
1. Disconnect mass air flow (MAF) connector and remove MAF harness from clip on air cleaner cover.
1. Remove air cleaner cover.
1. Locate Shutter Valve Actuator.

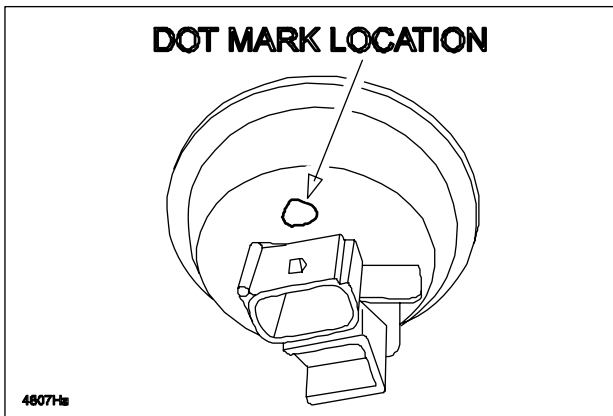
48071a

- If the Shutter Valve Actuator has a **YELLOW** identification dot located above the electrical connector, the part is modified, DO NOT REPLACE THE ACTUATOR. Proceed to "D. CAMPAIGN LABEL INSTALLATION"
- If the Shutter Valve Actuator has a **WHITE** identification dot located above the electrical connector, proceed to "C. REPAIR PROCEDURE" for actuator replacement.

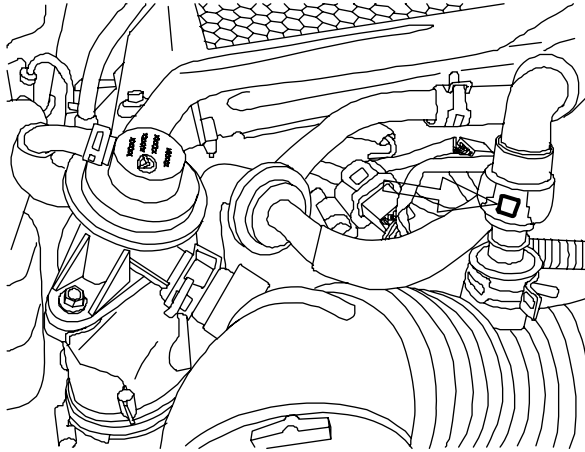
1. Record customer's radio station presets.
1. Disconnect negative battery cable.
1. Disconnect vent hose from air intake hose using quick disconnect, then remove air intake hose.

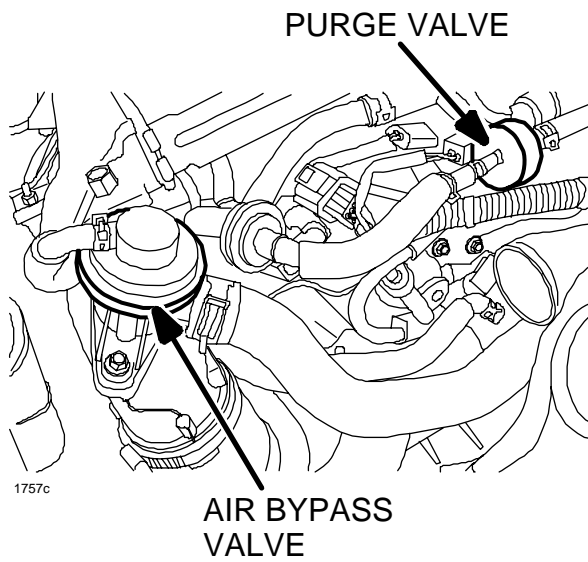
1. Disconnect air bypass hose from air bypass valve, and purge valve hose from purge valve, then move hoses up out of the way.

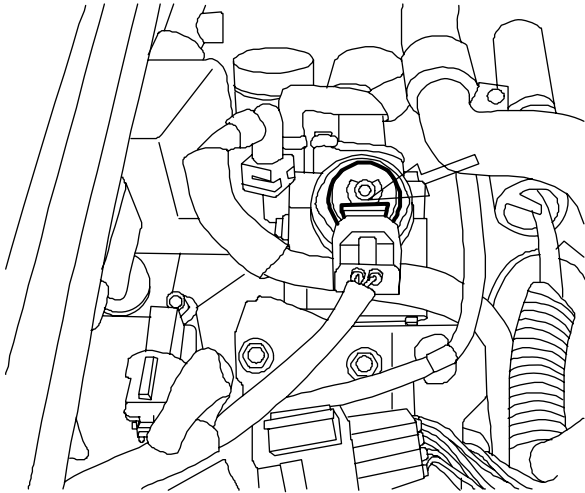
1757d

Disconnect high pressure fuel spill valve connector.

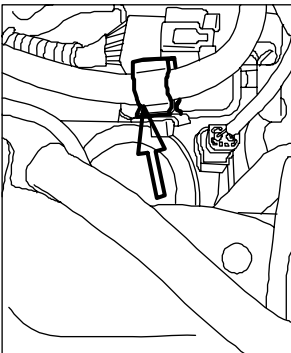
1757e

1. Disconnect hose from clip on wire harness bracket.

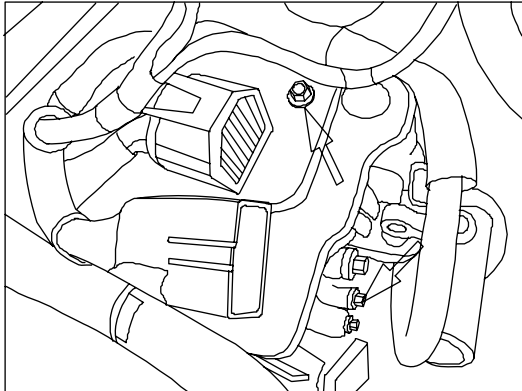
1757f

Remove two (2) bolts holding wire harness bracket and move bracket up and out of the way.

NOTE: It is not necessary to remove the ground wire bolt or disconnect the connectors as shown.

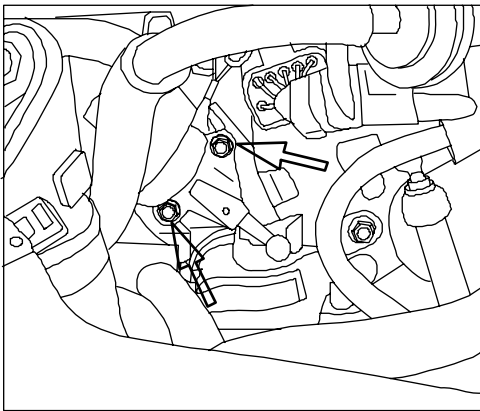
1757g

1. Remove two (2) bolts from variable swirl shutter valve actuator.

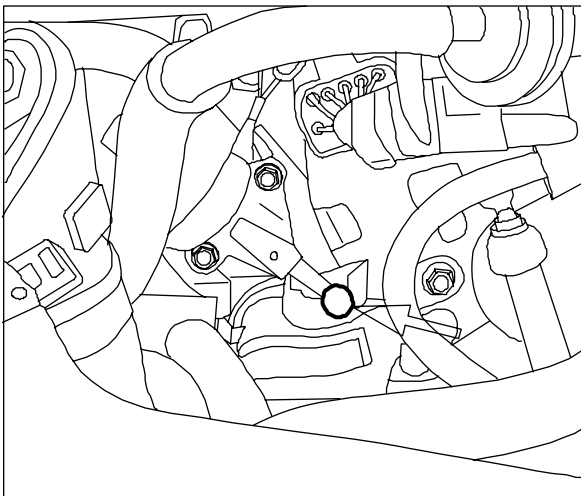
1757h

1. Using a hair dryer (NOT a heat gun), apply approximately 176° F (80° C) heat onto variable swirl shutter valve actuator ball joint for three (3) minutes.

CAUTION: Do not apply heat higher than 212° F (100° C) because it may cause damage to sensors.

Make sure ball joint gets warm, then disconnect joint.

CAUTION: Do not use a tool to disconnect the joint, otherwise the plate could get deformed.

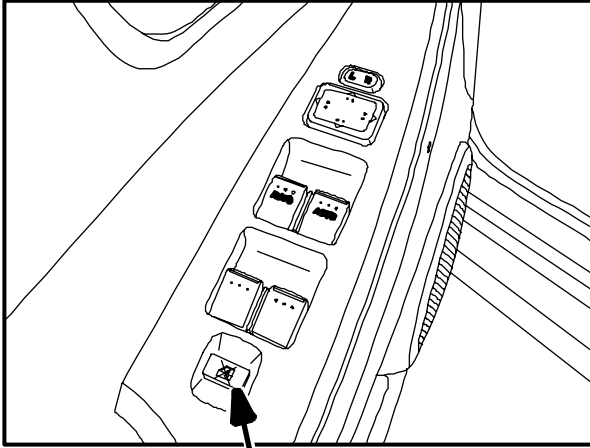
1601a

1. Turn ignition to ON position.
1. From driver's seat ensure window lockout switch is NOT depressed.

POWER WINDOW MAIN SWITCH

ENSURE WINDOW LOCKOUT SWITCH IS NOT DEPRESSED

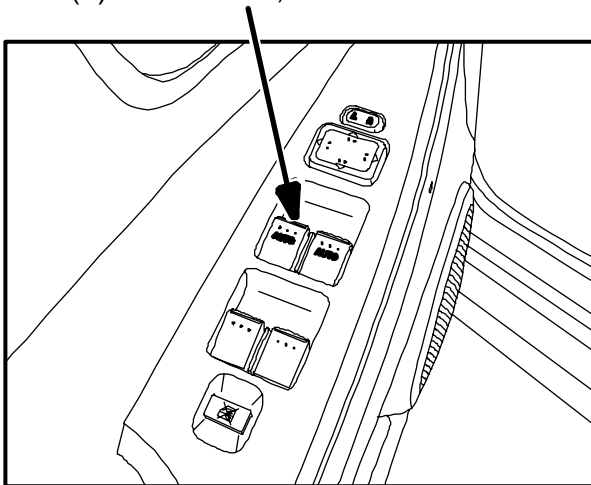
1601b

1. Press window switch down to fully open door window.
1. Pull window switch up to fully close door window; hold switch up for two (2) seconds; release switch.

OPEN WINDOW FULLY, CLOSE WINDOW FULLY HOLDING SWITCH UP FOR TWO(2) SECONDS, RELEASE SWITCH
