**Automatic Shoulder Belt  
Recall Campaign [72803]  
Door Latch Switch [SSP31]**

**1990-1994 323  
1992-1993 MX-3  
1990-1993 Protege**

**SUBJECT:** **Recall Campaign 72803 & Special Service Program – SSP31**  
1990 – 1994 323, 1992 – 1993 MX-3 and 1990 – 1993 Protege

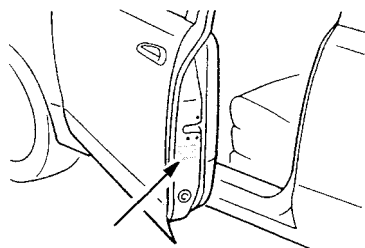
**INSPECT VEHICLE  
FOR RECALL OR SSP  
LABEL**

2. Perform a Vehicle Status inquiry using your **MDCS** System and inspect vehicle for an Authorized Modification Label **RECALL 72803 or SSP33** attached to the driver's side door. Refer to illustration below.

- If **MDCS** displays **RECALL 72803 or SSP33 Open** and an Authorized Modification Label is **not present**, the recall has not been performed. Proceed to "**B. CUSTOMER INQUIRY.**"

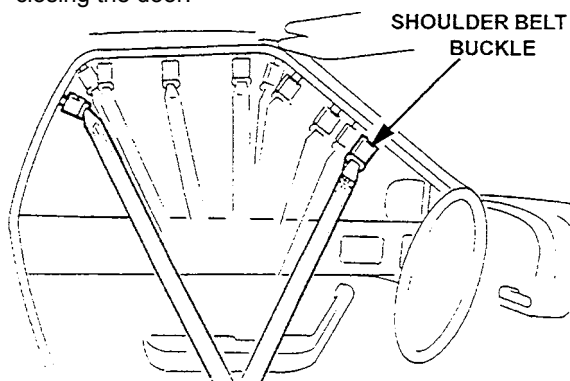
**[1990-93 323 & 1992-93 MX-3]**

1. Turn ON the ignition.
2. Check the automatic shoulder belt by opening and closing the door.

- If the buckle stays in the lock (rear-most) position when the door is opened, proceed to "**D. DOOR LATCH SWITCH REPLACEMENT**".
- If the buckle is stuck other than in the lock position, proceed to "**D. RAIL & MOTOR REPLACEMENT**".
- If the buckle operates properly, proceed to "**E. RAIL INSPECTION**".
