| Subject: MAZDA SPECIAL PROGRAM (MSP05) - O2 SENSOR DTC ERROR, P2195 / P2196 | Bulletin No: 01-xxx/04 |

APPLICABLE MODEL(S)/VINS

2004 MAZDA3, 2.0L Engine PZEV (Partial Zero Emission Vehicle), built from September 29, 2003 through July 2, 2004 (**California Emission Regulation Applicable Model only**)

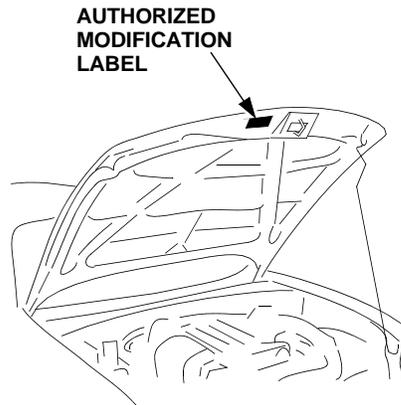
- Verify the vehicle is within the following VIN range, AND built from September 29, 2003 through July 2, 2004:
 - VIN Range: **JM1 BK**F* 41 100220 - JM1 BK**F* 41 206392**
 - If the vehicle is within the above VIN range, AND built from September 29, 2003 through July 2, 2004, proceed to Step 1.
 - If the vehicle is not within the above VIN range, return the vehicle to the customer or inventory.
- Perform a **Warranty Vehicle Inquiry** using your **eMDCS System** and inspect the vehicle for an Authorized Modification Label **MSP05** attached to the vehicle's hood.

NOTE: Verify the campaign number as the vehicle may have multiple labels.

6. Verify repair.
7. Complete the blue “**Authorized Modification**” label (9999-95-065A-00) with the **Campaign number “MSP05”** written on the sticker and affix it to the vehicle’s hood. Refer to the illustration under “**VEHICLE INSPECTION PROCEDURE**”.

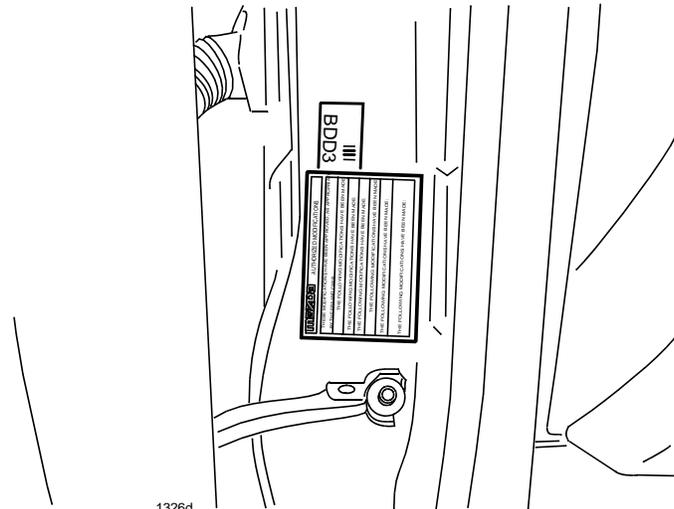
1326d

A rectangular label form with a dashed border. At the top left is the Mazda logo. To its right, the text reads "AUTHORIZED MODIFICATIONS". Below this, there are three lines of text: "THESE MODIFICATIONS HAVE BEEN APPROVED, AS APPROPRIATE, BY THE EPA AND CARB.", "THE FOLLOWING MODIFICATIONS HAVE BEEN MADE:", and a large rectangular area with a dotted border for listing modifications.
